**Flood Control Project Maintenance
Levee Inspections**

Fall 2015 Levee Maintenance Deficiency Summary Report

Sacramento River Basin

Reclamation District No. 0341 Sherman Island

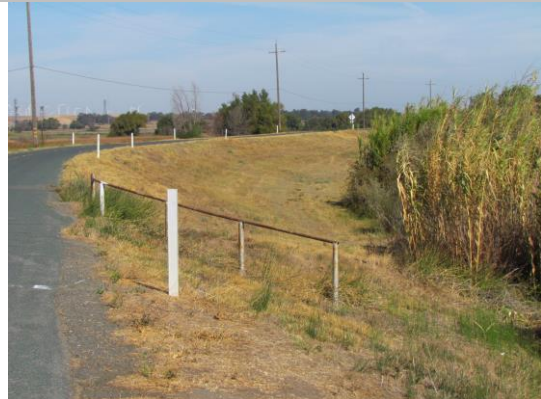
Photo 1 of 1 : FA_2015_RD0341_167_23_20151008_00013.jpg

LM Start	0.01	Rating **	A	Issue No.	23
LM End	1.95	Issue Type +	Ma	Location *	WS
Category	Earthen Levee			GPS Latitude/Longitude	
				Start	End
Item	Vegetation			38.085668 °	38.113412 °
				-121.686523 °	-121.684058 °
DWR ID	DWR_RD0341_01_f_2015_23				
Action/Comments					
Control annual grass and weeds on the levee slopes and easements. Inspector Comments: No unwanted vegetation.

RD 341 Looking downstream from levee mile 0.00 at mowed levee slope. The arundo has been sprayed.

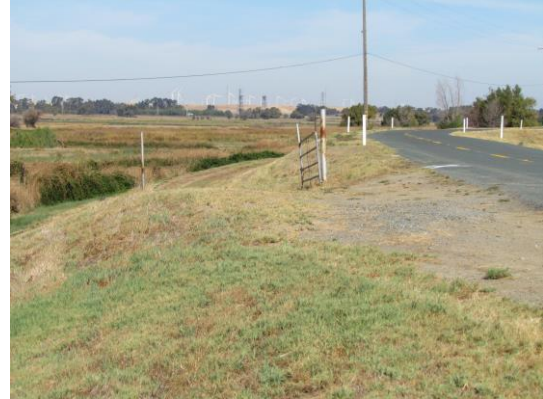
Photo 1 of 1 : FA_2015_RD0341_167_24_20151008_00014.jpg

LM Start	0.01	Rating **	A	Issue No.	24
LM End	3.33	Issue Type +	Ma	Location *	LS
Category	Earthen Levee			GPS Latitude/Longitude	
				Start	End
Item	Vegetation			38.085668 °	38.105183 °
				-121.686523 °	-121.702030 °
DWR ID	DWR_RD0341_01_f_2015_24				
Action/Comments					
Control annual grass and weeds on the levee slopes and easements. Inspector Comments: No unwanted vegetation present on slope.

RD 341 Looking downstream from levee mile 0.01 slopes has been mowed to levee mile 3.33.

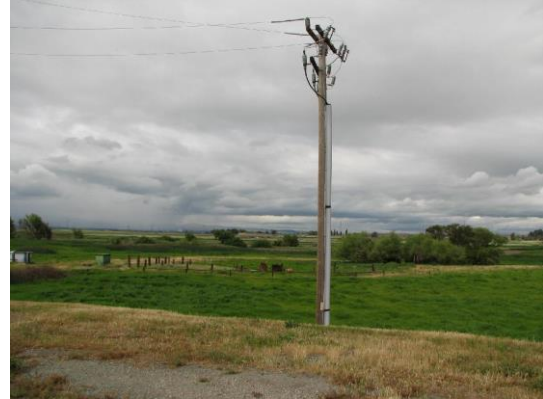
Photo 1 of 3 : UCIP_FA_2015_1752.jpg

Inspector Comments: FS_ID:22064
 DS_ID:24110
 EP_NO: 6297
 FS_HLM: 0.48
 Repair Type: Non-Urgent
 Crossing Status: Found
 UCIP Comments: Markers Missing. No markers found to confirm crossing is still in use--need to contact owner to determine status of crossing.
 FIELD_STRUCT_DESC: 3-inch electrical conduit through the levee, 3.5 feet below the crown. Location marker on waterward shoulder--no marker found. Pole on landward side. Rock revetment on waterward slope. (Permit No. 6297-1969)
 FS Date: 05/05/2009

Power pole located on landward side aligns with crossing.

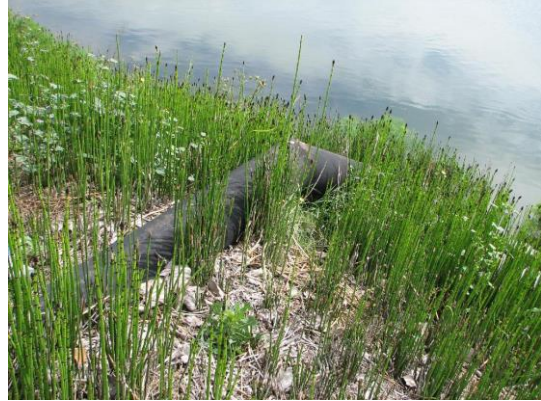
Photo 2 of 3 : UCIP_FA_2015_1755.jpg

Inspector Comments: FS_ID:22068
DS_ID:24111
EP_NO: 1477
FS_HLM: 0.5
Repair Type: Non-Urgent
Crossing Status: Found
UCIP Comments: Dense vegetation limits the inspector's visibility to identify signs of pipe failure (leaks) along the slopes. Recommend removing vegetation along pipe alignment to conduct proper inspection of structure and appurtenances.
FIELD_STRUCT_DESC: 10-inch steel pipe through the levee, 1.8 feet below the crown. Pipe is encased in 12-inch CM condutor pipe under crown. Pump on landward side. Air vent and metal distribution box with gate on the landward side. Rock revetment on the waterward slope. (USACE-1962). This entry matches the Drainage or Irrigation Structure referenced in O&M manual (HLM 0.50). 30-feet of pipe under crown was replaced and encased in CM pipe under Permit No. 1477 (1950).
FS Date: 05/05/2009

View of pipe on waterward side.

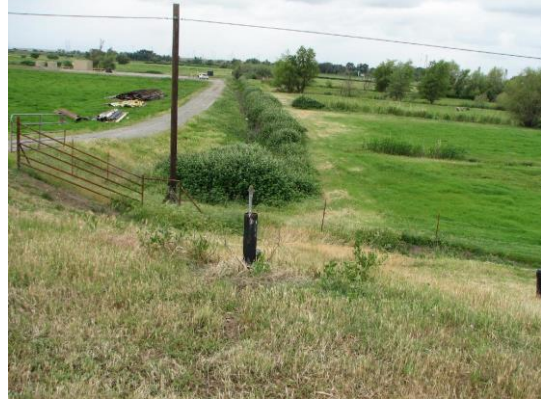
Photo 2 of 3 : UCIP_FA_2015_1758.jpg

Inspector Comments: FS_ID:22070
 DS_ID:24113
 EP_NO: 11095
 FS_HLM: 1.066
 Repair Type: Non-Urgent
 Crossing Status: Found
 UCIP Comments: Dense vegetation limits the inspector's visibility to identify signs of pipe failure (leaks) along the slope. Recommend removing vegetation along pipe alignment to conduct proper inspection of structure and appurtenances.
 FIELD_STRUCT_DESC: 18-inch pipe sleeved through 24-inch pipe through the levee, 4.0 feet below the crown. Air vent and monitoring well on landward side. Pipe exposed on the waterward slope. This pipe was retained under ABO No. 11095 (1975).
 FS Date: 05/05/2009

View of landward side--visible standup pipe on slope.

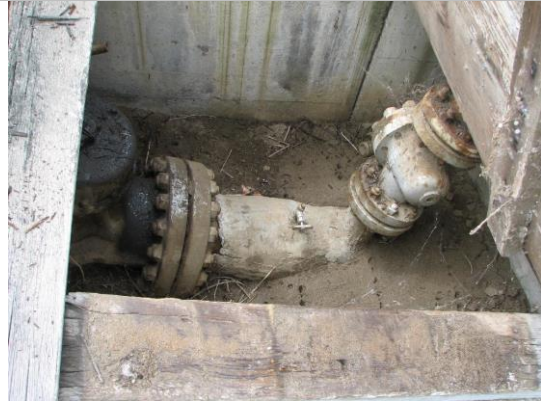
Photo 1 of 3 : UCIP_FA_2015_1760.jpg

LM Start	1.44	Rating **	M	Issue No.	31
LM End	1.44	Issue Type +	En	Location *	LS
Category	Supplemental			GPS Latitude/Longitude	
				Start	End
Item	DWR UCIP Field Study			38.106183 °	38.106183
				-121.685541 °	-121.685541 °
DWR ID					
Action/Comments					
Inspector Comments: FS_ID:22074 DS_ID:24115 EP_NO: N/A FS_HLM: 1.43 Repair Type: Non-Urgent Crossing Status: Found

Inside view of vault located on the landward side.

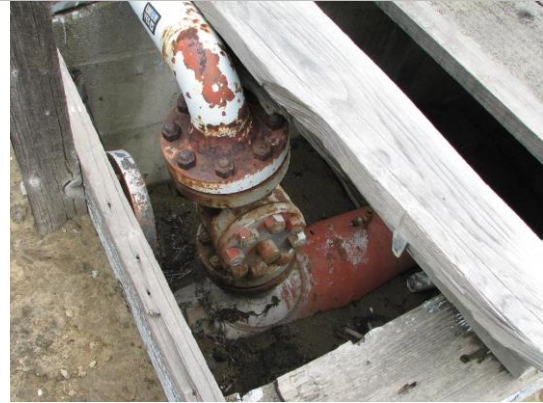
Photo 2 of 3 : UCIP_FA_2015_1764.jpg

Inspector Comments: FS_ID:22076
 DS_ID:24217
 EP_NO: N/A
 FS_HLM: 1.44
 Repair Type: Non-Urgent
 Crossing Status: Found
 UCIP Comments: Unknown detail of the size of crossing. Need to contact owner to determine if crossing is still active and to determine last inspection date. Will need copy of letter showing crossings passed inspection. NEED photo of emergency contact information from marker.
 FIELD_STRUCT_DESC: Gas line through the levee. (USACE-1962). This entry matches the Drainage or Irrigation Structure referenced in O&M manual (HLM 1.44).
 FS Date: 05/05/2009

View of pipe inside concrete box located on landward side.

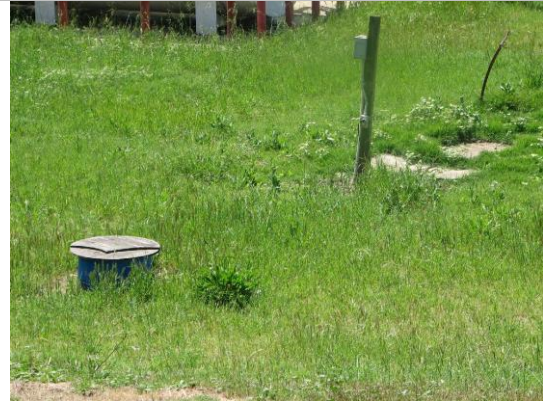
Photo 1 of 2 : UCIP_FA_2015_1788.jpg

LM Start	2.00	Rating **	M	Issue No.	34
LM End	2.00	Issue Type +	En	Location *	WS
Category	Supplemental			GPS Latitude/Longitude	
				Start	End
Item	DWR UCIP Field Study			38.114092 °	38.114092 °
				-121.684524 °	-121.684524 °
DWR ID					
Action/Comments					
Inspector Comments: FS_ID:22093					
DS_ID:24237					
EP_NO: 5427					
FS_HLM: 1.99					
Repair Type: Non-Urgent					
Crossing Status: Indicator Found

Electrical connection visible next to concrete pad--right corner.

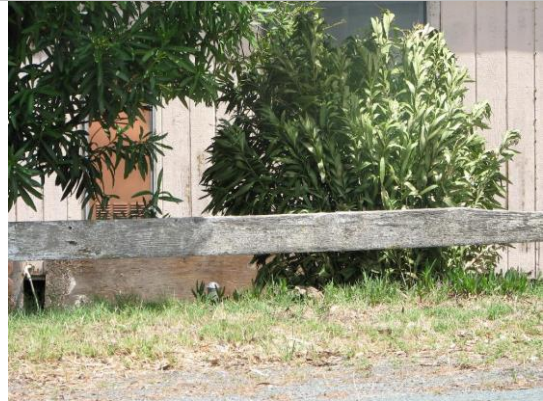
Photo 1 of 3 : UCIP_FA_2015_1785.jpg

LM Start	2.00	Rating **	M	Issue No.	35
LM End	2.00	Issue Type +	En	Location *	WS
Category	Supplemental			GPS Latitude/Longitude	
				Start	End
Item	DWR UCIP Field Study			38.114092 °	38.114092 °
				-121.684524 °	-121.684524 °
DWR ID					
Action/Comments					
Inspector Comments: FS_ID:22091					
DS_ID:24117					
EP_NO: 5427					
FS_HLM: 1.99					
Repair Type: Non-Urgent					
Crossing Status: Indicator Found

View of waterward side.

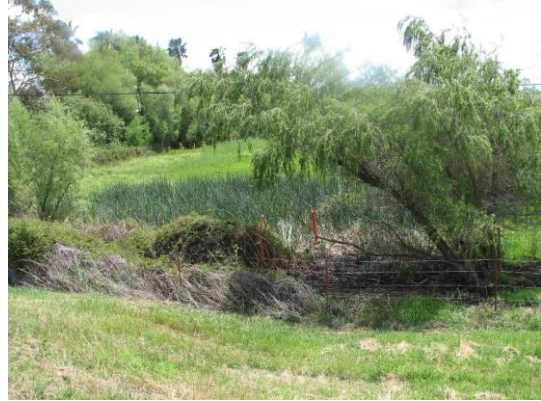
Photo 1 of 2 : UCIP_FA_2015_1792.jpg

Markers also visible on landward side near levee toe.

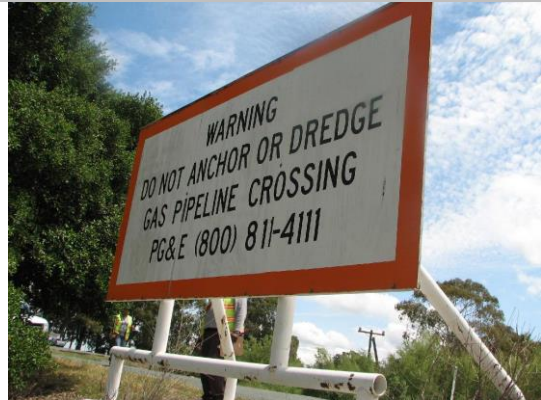
Photo 2 of 2 : UCIP_FA_2015_2392.jpg

Warning marker visible on waterward shoulder.

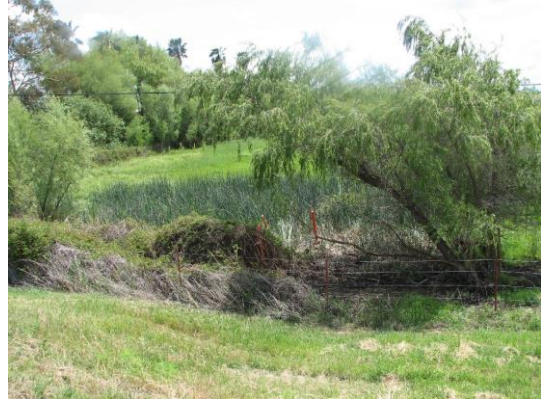
Photo 1 of 2 : UCIP_FA_2015_1790.jpg

Landward markers visible near levee toe.

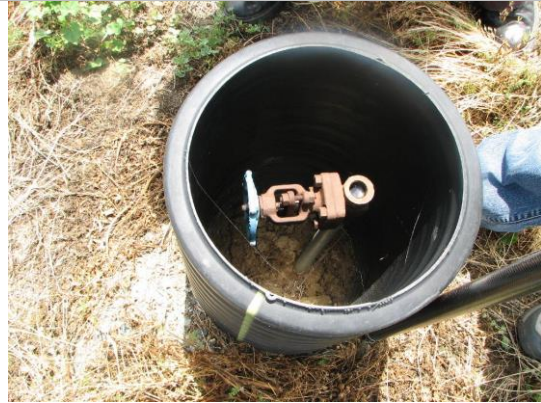
Photo 1 of 3 : UCIP_FA_2015_2393.jpg

Siphon breaker located on landward slope.

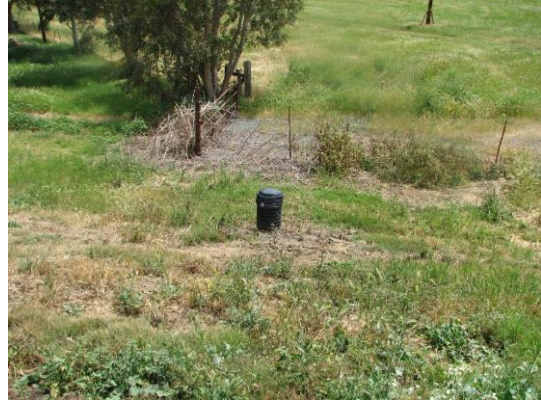
Photo 2 of 3 : UCIP_FA_2015_2400.jpg

Action/Comments					
Inspector Comments: FS_ID:22116 DS_ID:24238 EP_NO: N/A FS_HLM: 2.93 Repair Type: Non-Urgent Crossing Status: Indicator Found UCIP Comments: Pipe side does not match--found 10 inch instead of 8 inch. Pipe (2 of 2) was supposed to be removed and replaced with 12-inch steel irrigation pipes under Permit No. 5629 (1966). Historical Levee Logs from 1992 do not reflect that the replacement was completed, verify diameter of pipes and status with applicant. Dense vegetation limits the inspector's visibility to identify signs of pipe failure (leaks) along the slope. Recommend removing vegetation along pipe alignment to conduct proper inspection of structure and appurtenances. FIELD_STRUCT_DESC: 2 of 2: 10-inch (not 8-inch as originally mentioned in desk study) steel irrigation pipe through the levee, 1.6 feet below the crown. Siphon breaker on landward side. Irrigation ditch with distribution box at landward toe. Pipe exposed on both slopes. Rock revetment on waterward slope. (USACE-1962). This entry matches the Drainage or Irrigation Structure referenced in O&M manual (HLM 2.93). FS Date: 05/05/2009

Stand pipe located near levee toe on landward side.

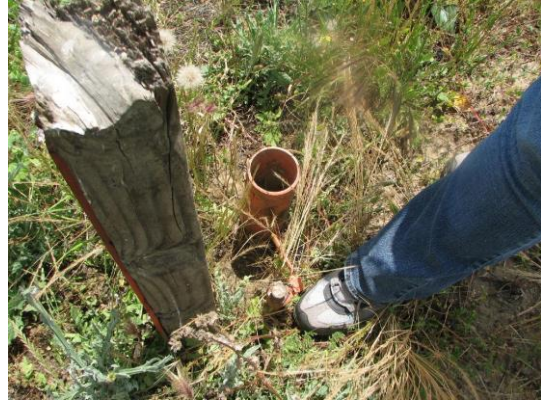
Photo 1 of 3 : UCIP_FA_2015_2396.jpg

Small stand pipe located on waterward side--unknown purpose of stand pipe.

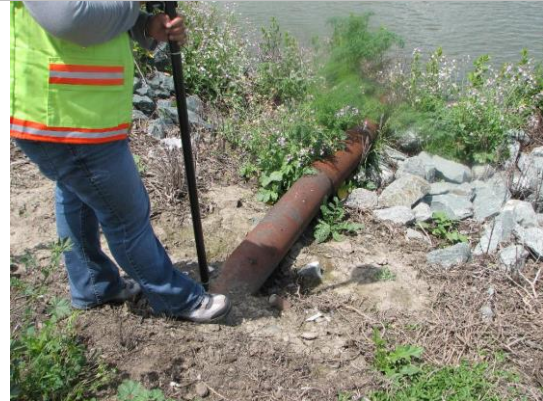
Photo 3 of 3 : UCIP_FA_2015_2398.jpg

View of pipe and rip rap located on waterward side.

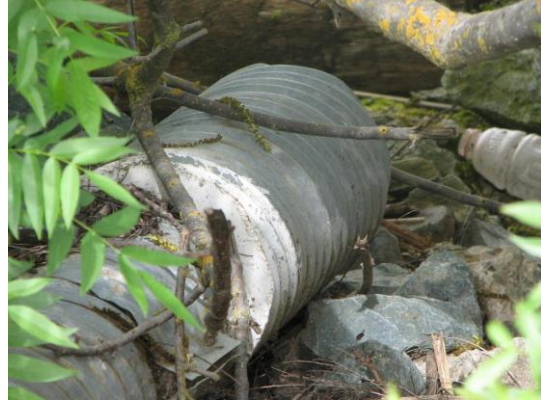
Photo 2 of 3 : UCIP_FA_2015_1670.jpg

View of corrugated metal pipe on waterward side.

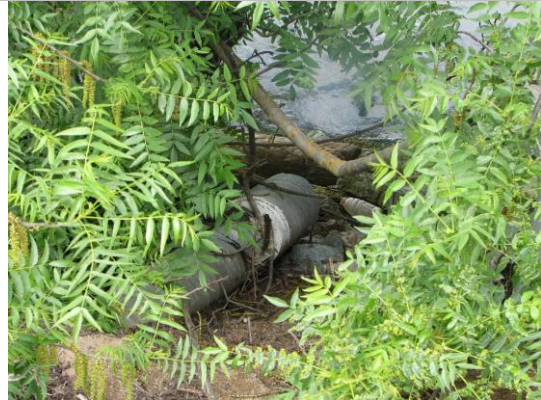
Photo 3 of 3 : UCIP_FA_2015_1671.jpg

Pipe on waterward side.

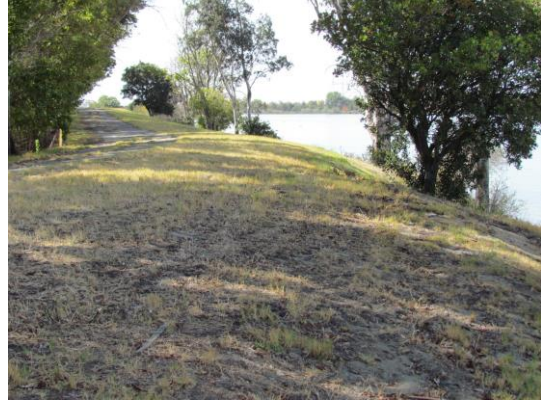
Photo 1 of 1 : FA_2015_RD0341_168_2_20151008_00021.jpg

LM Start	3.34	Rating **	M	Issue No.	2
LM End	3.37	Issue Type +	Ma	Location *	WS
Category	Earthen Levee			GPS Latitude/Longitude	
				Start	End
Item	Vegetation			38.105130 °	38.105313
				-121.702000 °	-121.702713
DWR ID	DWR_RD0341_02_f_2014_2				
Action/Comments					
Remove the wild growth other than native grasses from the levee slopes.

RD 341 Unit 2 looking downstream from levee mile 3.34 -3.37 waterside.

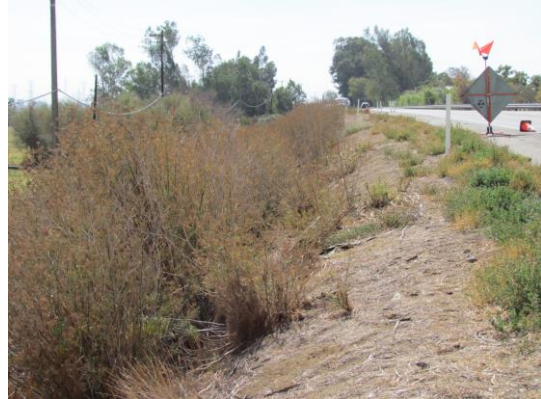
Photo 1 of 1 : FA_2015_RD0341_168_46_20151008_00024.jpg

LM Start	3.97	Rating **	U	Issue No.	46
LM End	6.15	Issue Type +	Ma	Location *	LS
Category	Earthen Levee			GPS Latitude/Longitude	
				Start	End
Item	Vegetation			38.097763 °	38.080323 °
				-121.706287 °	-121.730453 °
DWR ID	DWR_RD0341_02_f_2015_46				
Action/Comments					
Control annual grass and weeds on the levee slopes and easements. Inspector Comments: Remove the wild vegetation from the landside slope.

Looking downstream from the landside at tall anise weeds on the slope and toe.

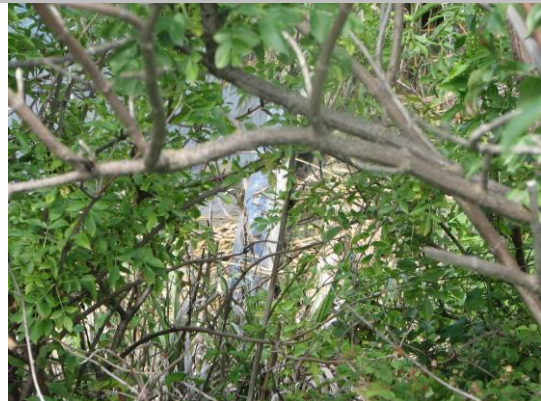
Photo 1 of 2 : UCIP_FA_2015_1732.jpg

LM Start	4.04	Rating **	M	Issue No.	51
LM End	4.04	Issue Type +	En	Location *	LS
Category	Supplemental			GPS Latitude/Longitude	
				Start	End
Item	DWR UCIP Field Study			38.096783 °	38.096783 °
				-121.706173 °	-121.706173 °
DWR ID					
Action/Comments					
Inspector Comments: FS_ID:22203 DS_ID:24135 EP_NO: 11110 FS_HLM: 4.03 Repair Type: Non-Urgent Crossing Status: Found UCIP Comments: Need to determine status of crossing--need to contact owner. Dense vegetation limits the inspector's visibility to identify signs of pipe failure (leaks) along the slope. Recommend removing vegetation along pipe alignment to conduct proper inspection of structure and appurtenances. FIELD_STRUCT_DESC: 10-inch pipe sleeved through 12-inch pipe through the levee, 3.8 feet below the crown. Pump on concrete well on landward slope. (USACE-1962). This entry matches the Drainage or Irrigation Structure referenced in O&M manual (HLM 4.03). 10-inch pipe was retained under ABO No. 11110 (1975). FS Date: 05/06/2009

Limited access to waterward side--pipe visible through brush.

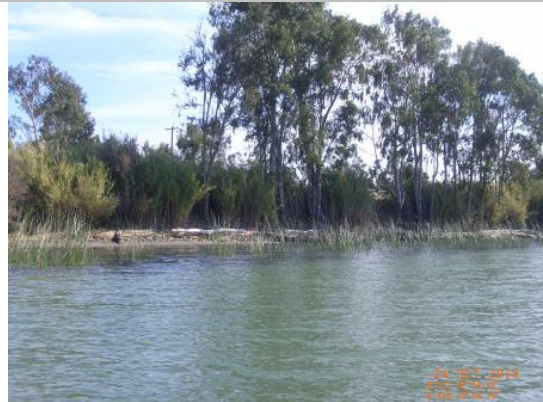
Photo 1 of 1 : USACE2013A_SAC_8-2_L_2.jpg

LM Start	4.15	Rating **	M	Issue No.	7
LM End	4.19	Issue Type +	Ma	Location *	WS
Category	Supplemental			GPS Latitude/Longitude	
				Start	End
Item	2015 USACE Erosion Survey, DRAFT			38.095148 °	38.094590 °
				-121.706367 °	-121.706393 °
DWR ID					
Action/Comments					
Inspector Comments: 2011 - Large new erosion pocket probably hidden by vegetation in the past. 2015: No observed changes. [2015 Site ID: SAC_8-2_L]

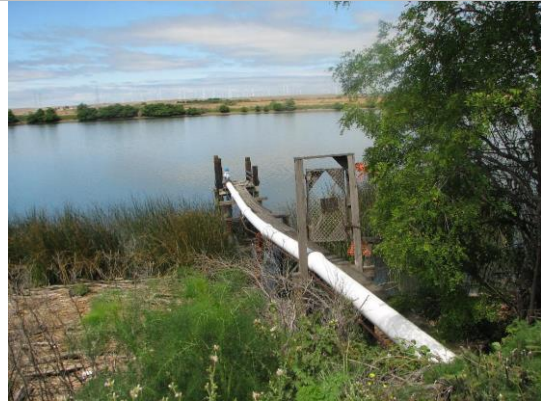
Photo 1 of 1 : UCIP_FA_2015_1734.jpg

LM Start	4.31	Rating **	M	Issue No.	52
LM End	4.31	Issue Type +	En	Location *	WS
Category	Supplemental			GPS Latitude/Longitude	
				Start	End
Item	DWR UCIP Field Study			38.092900 °	38.092900 °
				-121.706070 °	-121.706070 °
DWR ID					
Action/Comments					
Inspector Comments: FS_ID:22223 DS_ID:24122 EP_NO: 11106 FS_HLM: 4.29 Repair Type: Non-Urgent Crossing Status: Found UCIP Comments: Need to contact owner to determine status of crossing. Dense vegetation limits the inspector's visibility to identify signs of pipe failure (leaks) along the slope. Recommend removing vegetation along pipe alignment to conduct proper inspection of structure and appurtenances. FIELD_STRUCT_DESC: 12-inch pipe through the levee, 4.0 feet below the crown. Pump on pile structure in stream. (USACE-1962). This entry matches the Drainage or Irrigation Structure referenced in O&M manual (HLM 4.29). 12-inch pipe was retained under ABO No. 11106 (1975). FS Date: 05/06/2009

View of waterward side--pipe and pump visible.

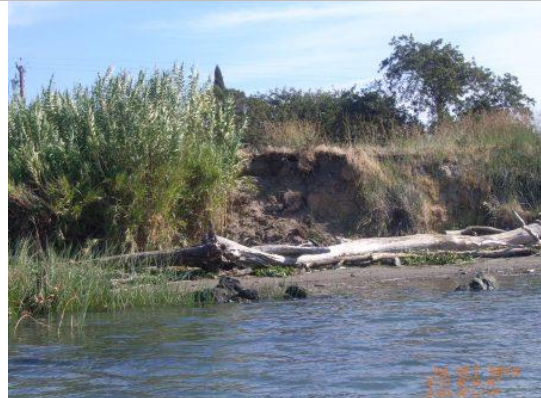
Photo 1 of 1 : USACE2013A_SAC_8-0_L_2.jpg

LM Start	4.47	Rating **	U	Issue No.	3
LM End	4.62	Issue Type +	Ma	Location *	WS
Category	Supplemental			GPS Latitude/Longitude	
				Start	End
Item	2015 USACE Erosion Survey, DRAFT			38.090620 °	38.088572 °
				-121.706684 °	-121.707127 °
DWR ID					
Action/Comments					
Inspector Comments: 1999 - New small slump in eroded bank. 2005 - Reach extended because of vertical bank along the roadway upstream. 2011 - More slumping since last year. 2012 - Site upgraded to critical. Very steep slope which may be effecting the highway on top of the levee. 2015: New erosion towards downstream end of site. [2015 Site ID: SAC_8-0_L]

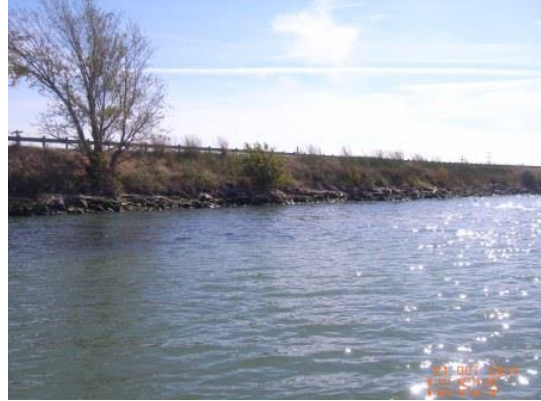
Photo 1 of 1 : USACE2013A_SAC_7-9_L_1.jpg

LM Start	4.76	Rating **	U	Issue No.	4
LM End	4.85	Issue Type +	Ma	Location *	WS
Category	Supplemental			GPS Latitude/Longitude	
				Start	End
Item	2015 USACE Erosion Survey, DRAFT			38.086603 °	38.085459 °
				-121.707786 °	-121.708607 °
DWR ID					
Action/Comments					
Inspector Comments: 2011 - Large slump section. 2012 - Site extended downstream, upgraded to critical, severe windwave. Slope is very steep and may be effecting the highway on top of the levee. 2015: No observed changes. [2015 Site ID: SAC_7-9_L]

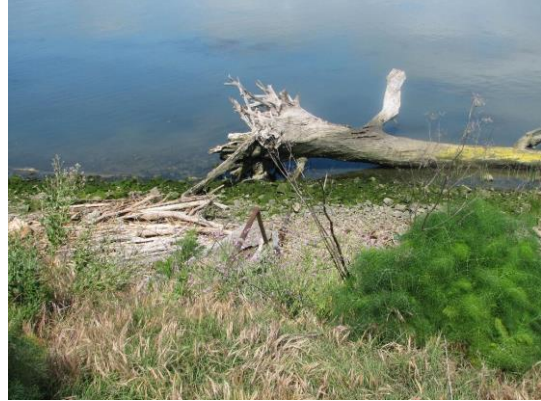
Photo 2 of 2 : UCIP_FA_2015_1673.jpg

LM Start	4.79	Rating **	M	Issue No.	53 (cont)	
LM End	4.79	Issue Type +	En	Location *	WS	
Category	Supplemental			GPS Latitude/Longitude		
				Start	End	
Item	DWR UCIP Field Study			38.086119 °	38.086119 °	
				-121.707912 °	-121.707912 °	
DWR ID						
Action/Comments						
Inspector Comments: FS_ID:22186 DS_ID:24123 EP_NO: 4855 FS_HLM: 4.76 Repair Type: Non-Urgent Crossing Status: Found UCIP Comments: Dense vegetation limits the inspector's visibility to identify signs of pipe failure (leaks) along the slope. Recommend removing vegetation along pipe alignment to conduct proper inspection of structure and appurtenances. FIELD_STRUCT_DESC: 2-inch steel irrigation pipe through the levee, 3.0 feet below the crown. Valve and pump on landward side. Rock revetment on waterward slope. (Permit No. 4855-1965) FS Date: 05/06/2009

View of crossing on waterward side--dense vegetation on slopes.

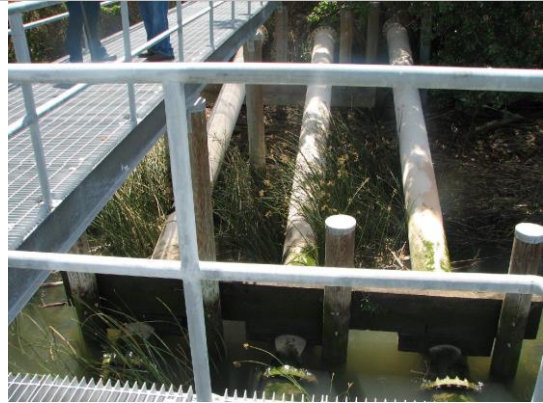
Photo 2 of 3 : UCIP_FA_2015_2350.jpg

View of waterward side - 3-20 inch pipes.

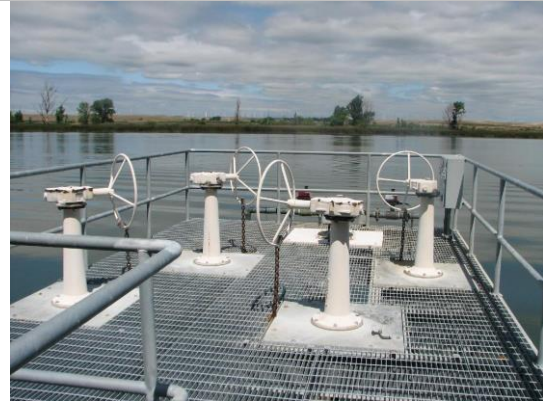
Photo 3 of 4 : UCIP_FA_2015_2354.jpg

Gates located on waterward side.

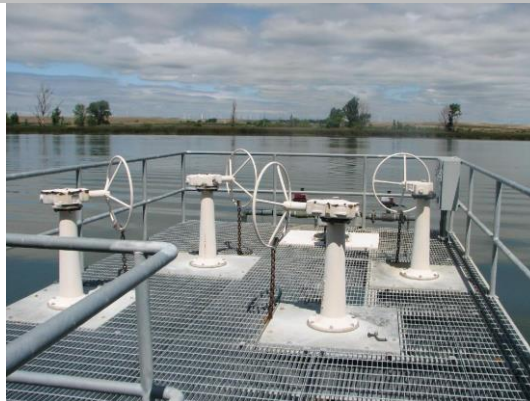
Photo 1 of 3 : UCIP_FA_2015_2356.jpg

Gates located on waterward side.

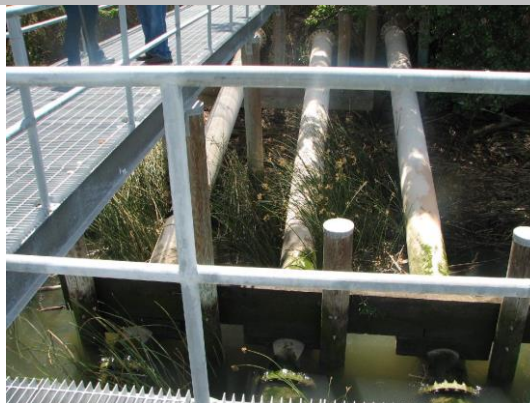
Photo 2 of 3 : UCIP_FA_2015_2357.jpg

View of waterward side - 3-20 inch pipes.

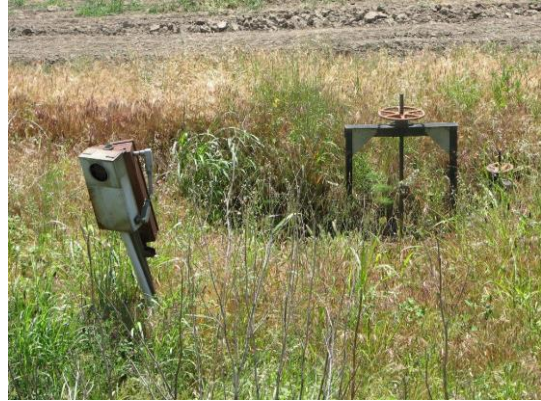
Photo 1 of 4 : UCIP_FA_2015_2433.jpg

Control panel and slide gate visible on landward toe.

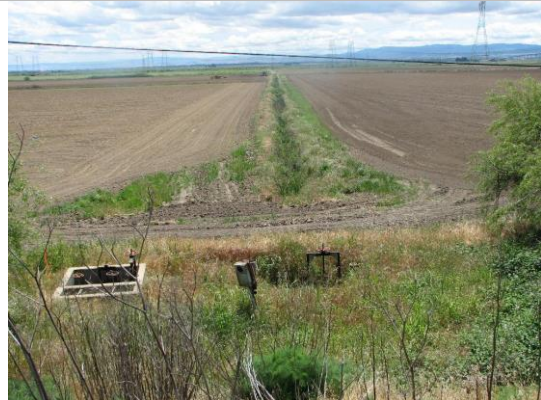
Photo 2 of 4 : UCIP_FA_2015_2434.jpg

Gate located at the toe of the levee on landward side.

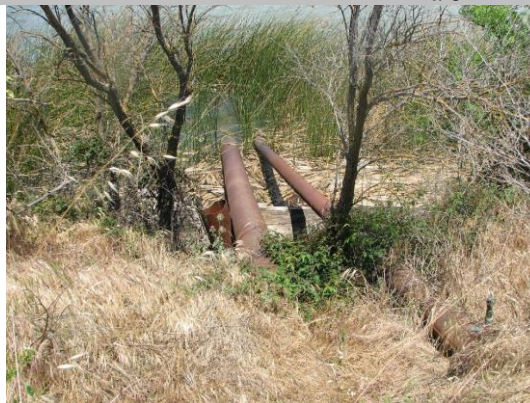
Photo 3 of 4 : UCIP_FA_2015_2438.jpg

View of pipes on waterward side.

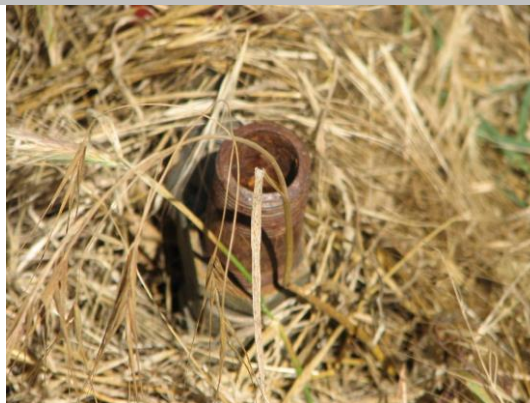
Photo 4 of 4 : UCIP_FA_2015_2439.jpg

Air vent located on waterward side.

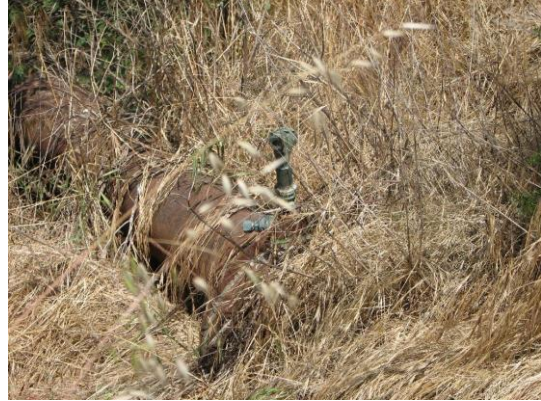
Photo 1 of 3 : UCIP_FA_2015_2435.jpg

Air vent located on waterward side.

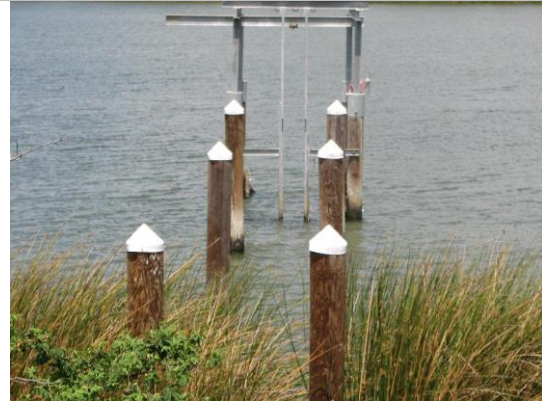
Photo 3 of 3 : UCIP_FA_2015_6535.jpg

Inspector Comments: FS_ID:39861
DS_ID:24076
EP_NO: 11116
FS_HLM: 6.12
Repair Type: Non-Urgent
Crossing Status: Found
UCIP Comments: Need to contact owner to determine status of crossing. If crossing is no longer used will need to meet Title 23 requirements. Hole present in pipe section. Debris on waterward side-- 10-inch pipe section abandoned on slope. Dense vegetation limits the inspector's visibility to identify signs of pipe failure (leaks) along the slope. Recommend removing vegetation along pipe alignment to conduct proper inspection of structure and appurtenances.
FIELD_STRUCT_DESC: 12-inch pipe sleeved through 14-inch pipe through levee, 4.0 feet below crown. Annular gap grouted. Slide gate in distribution box on landward side. (USACE-1962). This entry matches the Drainage or Irrigation Structure referenced in O&M manual (HLM 6.12). This pipe was retained under ABO No. 11116 (1975). Distribution box installed and pipe along landward slope removed and replaced with longer 16-inch steel pipe under Permit No. 15372 (1993).

View of structure located on waterward side.

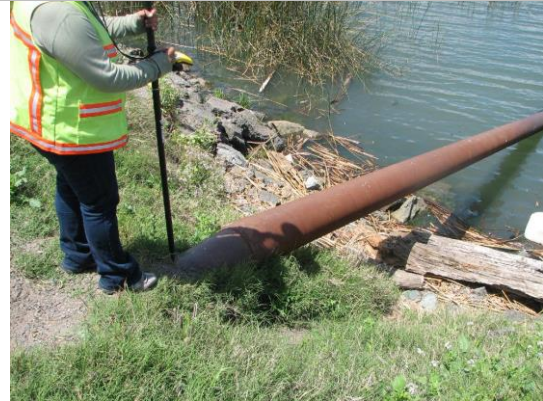
Photo 1 of 3 : UCIP_FA_2015_2440.jpg

View of pipe and rip rap on waterward side.

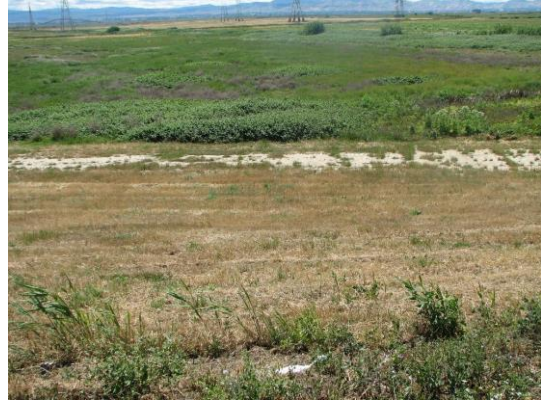
Photo 2 of 2 : UCIP_FA_2015_2444.jpg

Inspector Comments: FS_ID:22262
DS_ID:24079
EP_NO: 11107
FS_HLM: 6.55
Repair Type: Non-Urgent
Crossing Status: Indicator Found
UCIP Comments: Need to contact owner to determine status of crossing. If crossing is no longer in used owner will need to comply with Title 23. Dense vegetation limits the inspector's visibility to identify signs of pipe failure (leaks) along the slope. Recommend removing vegetation along pipe alignment to conduct proper inspection of structure and appurtenances.
FIELD_STRUCT_DESC: 4-inch pipe through the levee, 4.0 feet below the crown. This pipe was retained under ABO No. 11107 (1975).
FS Date: 05/06/2009

View of landward side no evidence of crossing.

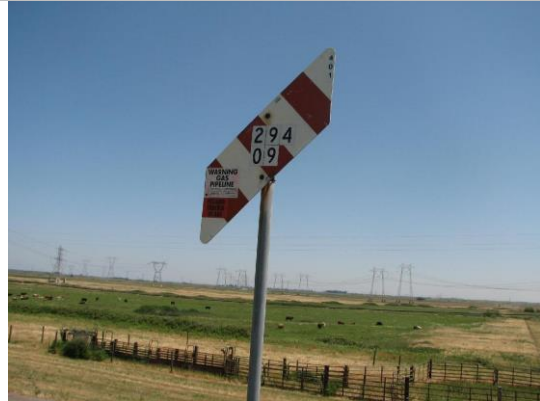
Photo 2 of 2 : UCIP_FA_2015_2476.jpg

Inspector Comments: FS_ID:22267
DS_ID:24193
EP_NO: 15777
FS_HLM: 7.02
Repair Type: Non-Urgent
Crossing Status: Indicator Found
UCIP Comments: Need to contact owner to determine status of crossing. Need date of last inspection and confirmation that crossing is still in operable condition. Multiple crossings in general area need to clarify which pipes are in this levee section.
FIELD_STRUCT_DESC: 42-inch steel gas pipeline through the levee, approximately 30.0 feet below the crown. (Permit No. 15777-1993)
Utility marker contact information includes Contact prior to Excavation call 1-800-227-2600 or Emergency Contact 1-800-811-4111.
FS Date: 05/06/2009

Marker located on landward side.

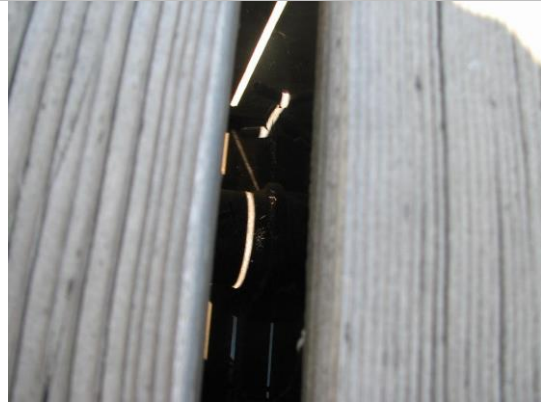
Photo 2 of 3 : UCIP_FA_2015_2406.jpg

Unable to confirm the number of pipe through section of levee.

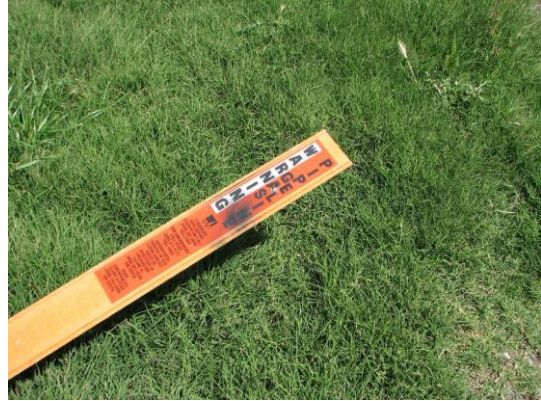
Photo 1 of 3 : UCIP_FA_2015_2402.jpg

Marker damaged on waterward side.

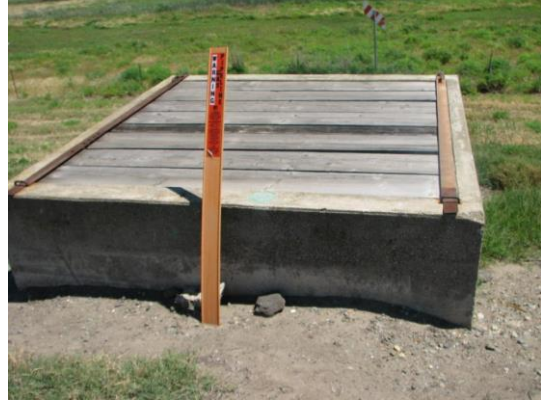
Photo 3 of 3 : UCIP_FA_2015_2404.jpg

View of landward side. Concrete box and markers indicating gas pipeline. Additional marker located at levee toe.

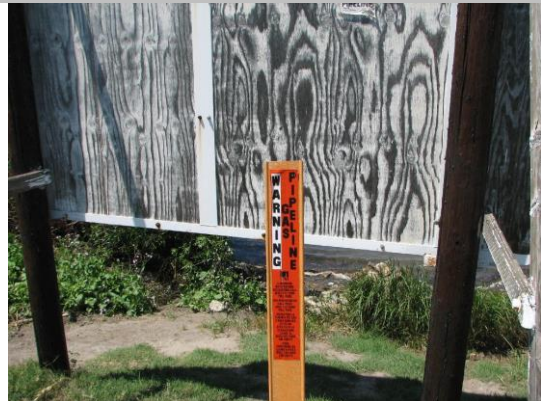
Photo 1 of 2 : UCIP_FA_2015_2477.jpg

Utility marker located on waterward side.

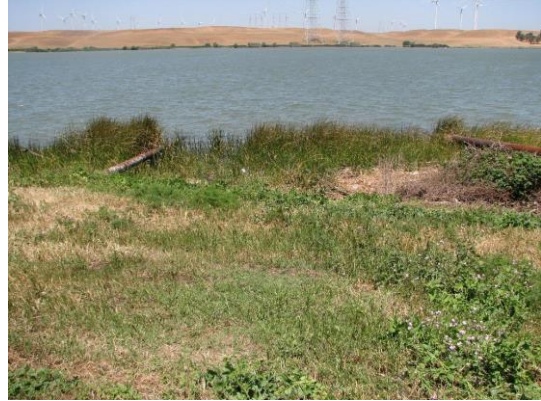
Photo 1 of 3 : UCIP_FA_2015_2525.jpg

LM Start	7.62	Rating **	M	Issue No.	72
LM End	7.62	Issue Type +	En	Location *	LS
Category	Supplemental			GPS Latitude/Longitude	
				Start	End
Item	DWR UCIP Field Study			38.076229 °	38.076229 °
				-121.753363 °	-121.753363 °
DWR ID					
Action/Comments					
Inspector Comments: FS_ID:22294 DS_ID:24243 EP_NO: 10799 FS_HLM: 7.53 Repair Type: Non-Urgent Crossing Status: Found UCIP Comments: Will need to contact owner. Need to obtain maintenance records and clarify modifications made at to crossing (size). Also important to note that DWR DOE was out in the field during our pipe inspection they were conducting pipe evaluation for pipe replacement. Need to contact DWR DOE to determine location of pipe replacement. FIELD_STRUCT_DESC: 12-inch steel irrigation pipe through the levee, 5.3 feet below the crown. Steel cutoff wall around pipe at center of levee. Siphon breaker on landward shoulder. Steel (not concrete as mentioned in historical records) pipe riser on landward side. 2-inch pipe sleeve around pipe at waterward shoulder. Rock revetment on waterward slope. Pipe exposed along waterward slope. (Permit No. 10799-1977) FS Date: 05/06/2009

Overview of waterward side- 12-inch pipe located on left side and 18-inch pipe located on right side.

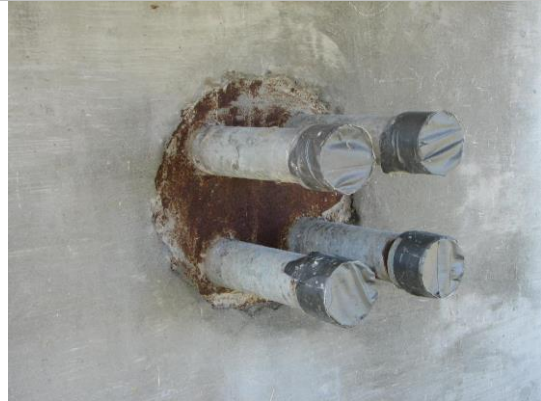
Photo 2 of 3 : UCIP_FA_2015_2548.jpg

Conduits exposed on waterward side.

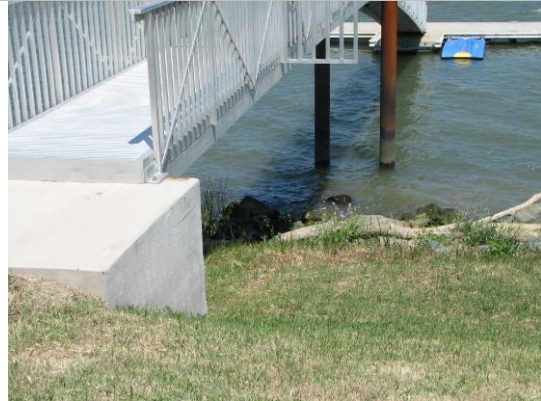
Photo 1 of 1 : UCIP_FA_2015_2550.jpg

Dock installed at levee mile 7.91.

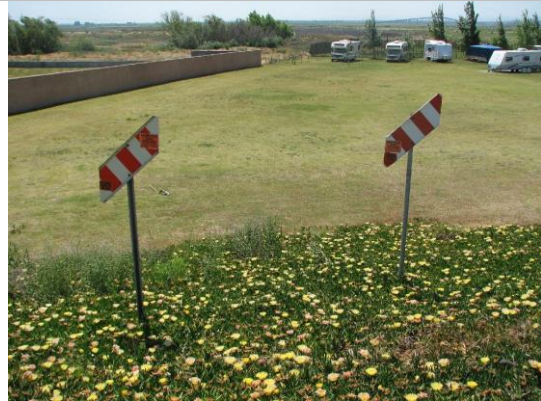
Photo 2 of 3 : UCIP_FA_2015_2555.jpg

Gas line markers located on landward side.

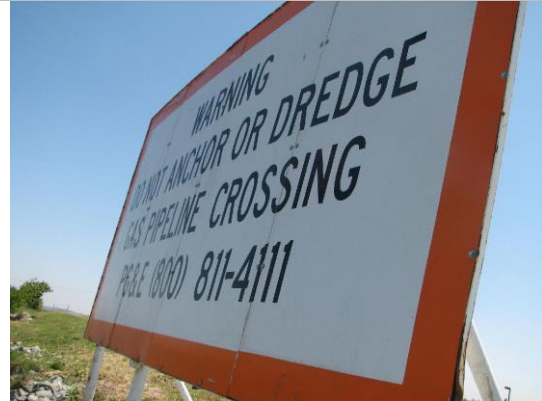
Photo 1 of 3 : UCIP_FA_2015_2551.jpg

Gas line crossing sign located on waterward side.

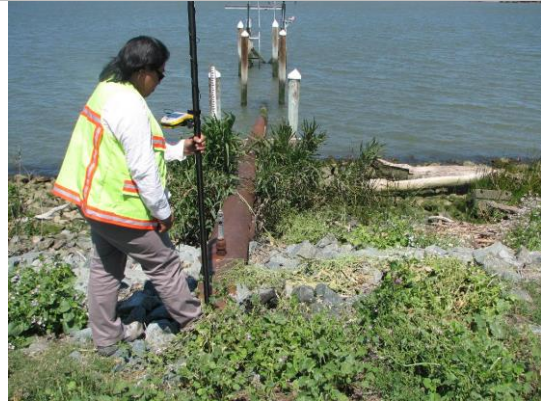
Photo 2 of 3 : UCIP_FA_2015_2294.jpg

Overview of crossing on waterward side.

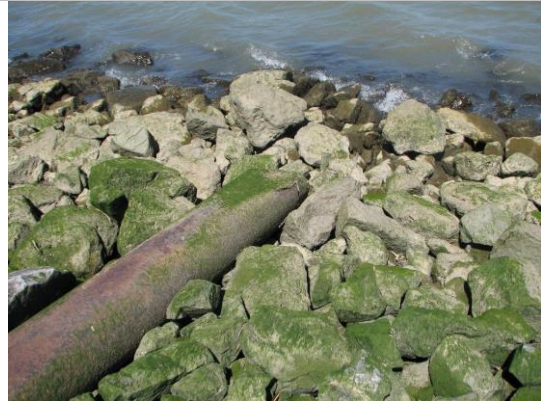
Photo 1 of 3 : UCIP_FA_2015_2297.jpg

Deformed pipe end located on waterward side.

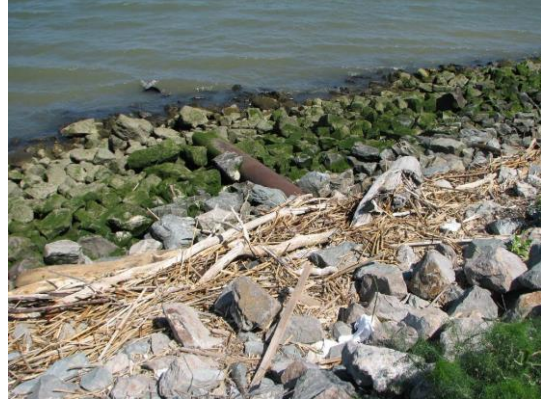
Photo 3 of 3 : UCIP_FA_2015_2299.jpg

Overview of waterward side. Slope protection along bank.

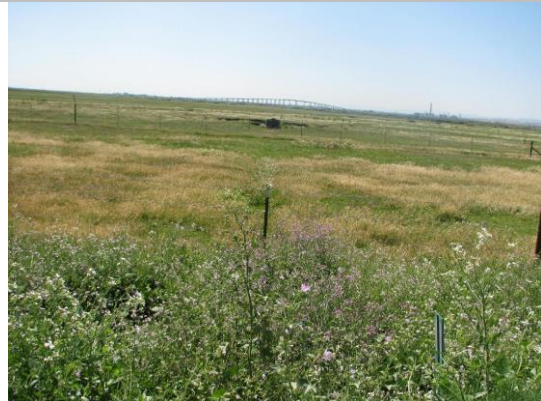
Photo 1 of 3 : UCIP_FA_2015_2296.jpg

Overview of landward side.

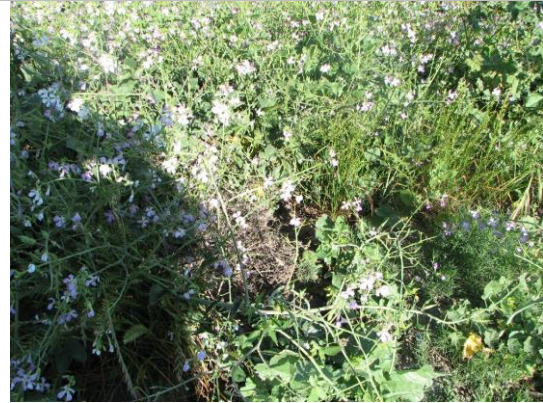
Photo 2 of 3 : UCIP_FA_2015_2300.jpg

Potential subsidence in slope however difficult to determine due to dense vegetation.
